FARR

Case Study

Don't Let This Happen to Your Clean Air System

Product: HemiPleat®
Size: GS16
Application: Metal
Customer: Quantum Metals-Lebanon, Ohio
Representative: Air/Pro

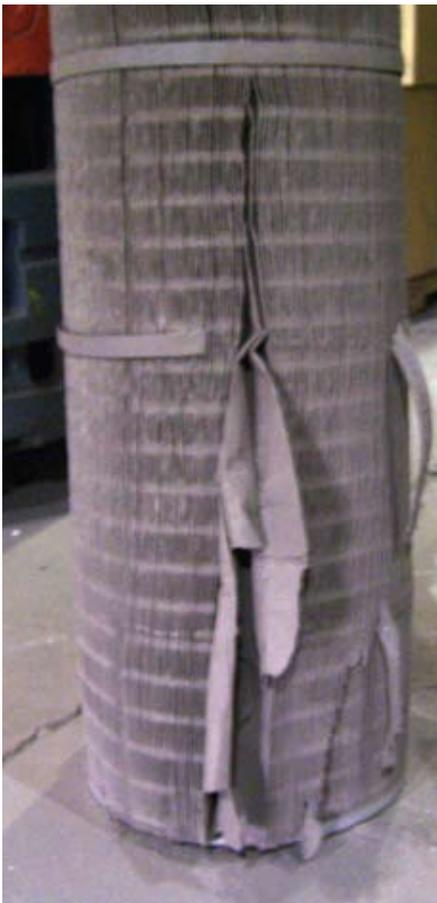
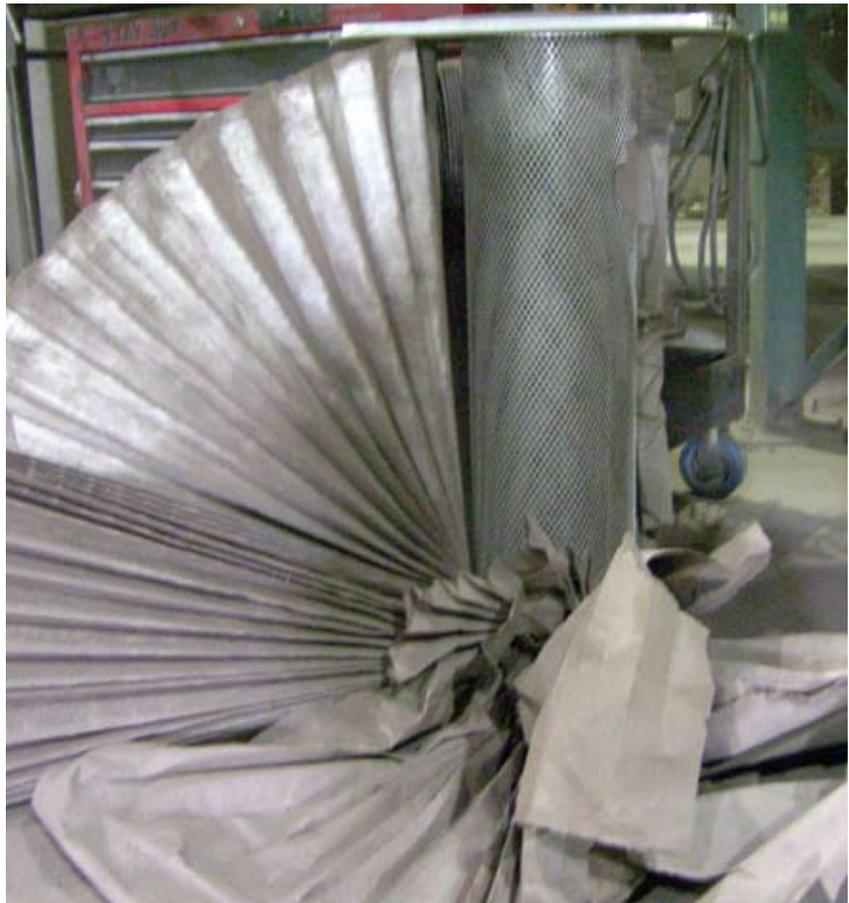
Not all aftermarket filters can withstand the power of the Gold Series® cleaning system.

Fuchs contacted Farr APC when the second round of aftermarket filters failed. The aftermarket filters could not withstand the pressure from the pulsing of the Gold Series®. Nylon straps which hold the filter together came off and the filter paper became unglued. Flanges were warped, seals ruptured, and bottom pans separated.

A second round of aftermarket filters was installed to replace the first set. These filters again did not last more than two weeks before breaking down. When the GS filter compartment was opened, one of the aftermarket filters had come off the track and was lying sideways in the dust collection unit, dramatic evidence of its catastrophic failure when installed in the Farr Gold Series.

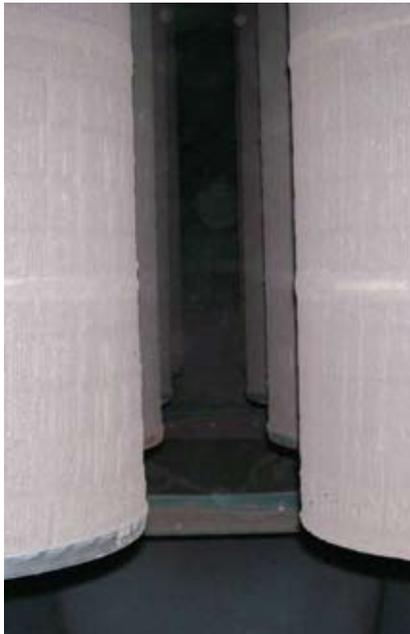
These filter pleats are plugged full of dust.

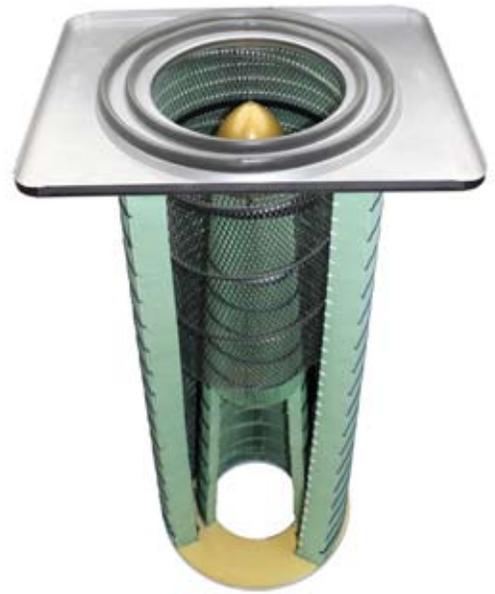
HemiPleat® has more available/usable media for filtration.

While the Gold Series® was working perfectly, the aftermarket filters inside were not. Quantum Metals made the decision to contact Farr APC in order to get their GS16 working at top capacity. Farr APC worked with Fuchs beginning in September of 2008 and by the end of the first business day, a quote was made, and an order for Gold Cone™ HemiPleat® filters was placed. With the new filters in place, Quantum Metals has not seen any problems and the GS16 is again running smoothly, as it did with the original, long-lasting, filters in place.

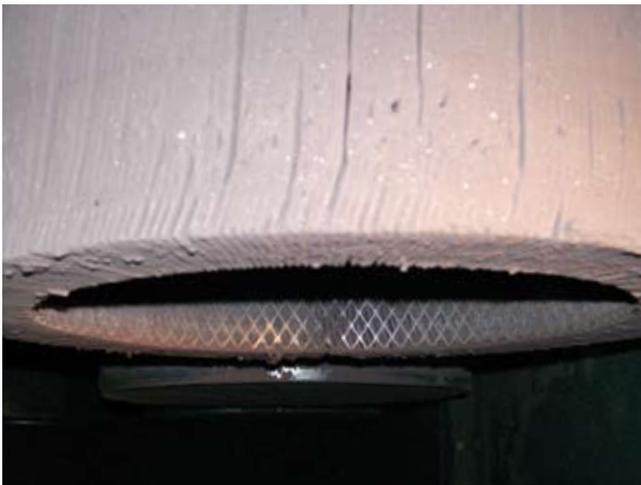
The **bottom** fell out and dust went everywhere.

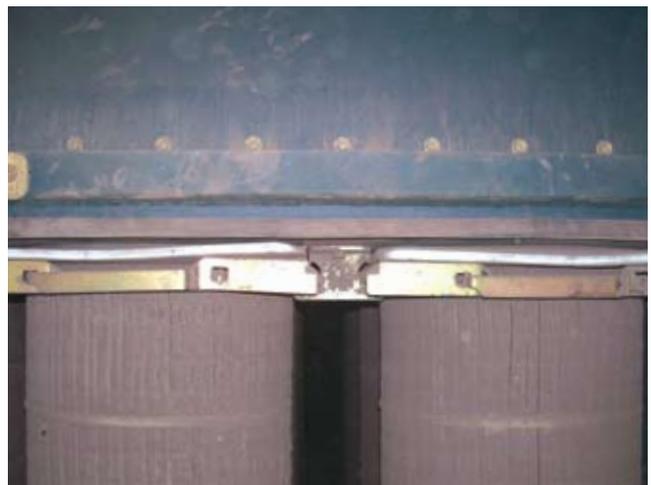
Warped mounting plates encourage gasket leaks.
